# Workshop 42

### Changing the high speed oil sensor on a Terrano ZD 3.0 engine

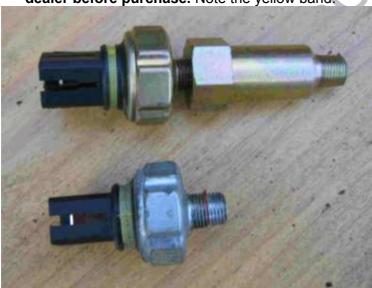
1) Oil sensor Nissan part number 25240-2X901 or sensor with extension and thread-lock (Loctite 271) kit 10007-2X90B please check part numbers with dealer before purchase. Note the yellow band.
