Workshop 5

Adjusting the Tappets

TD27B Engine

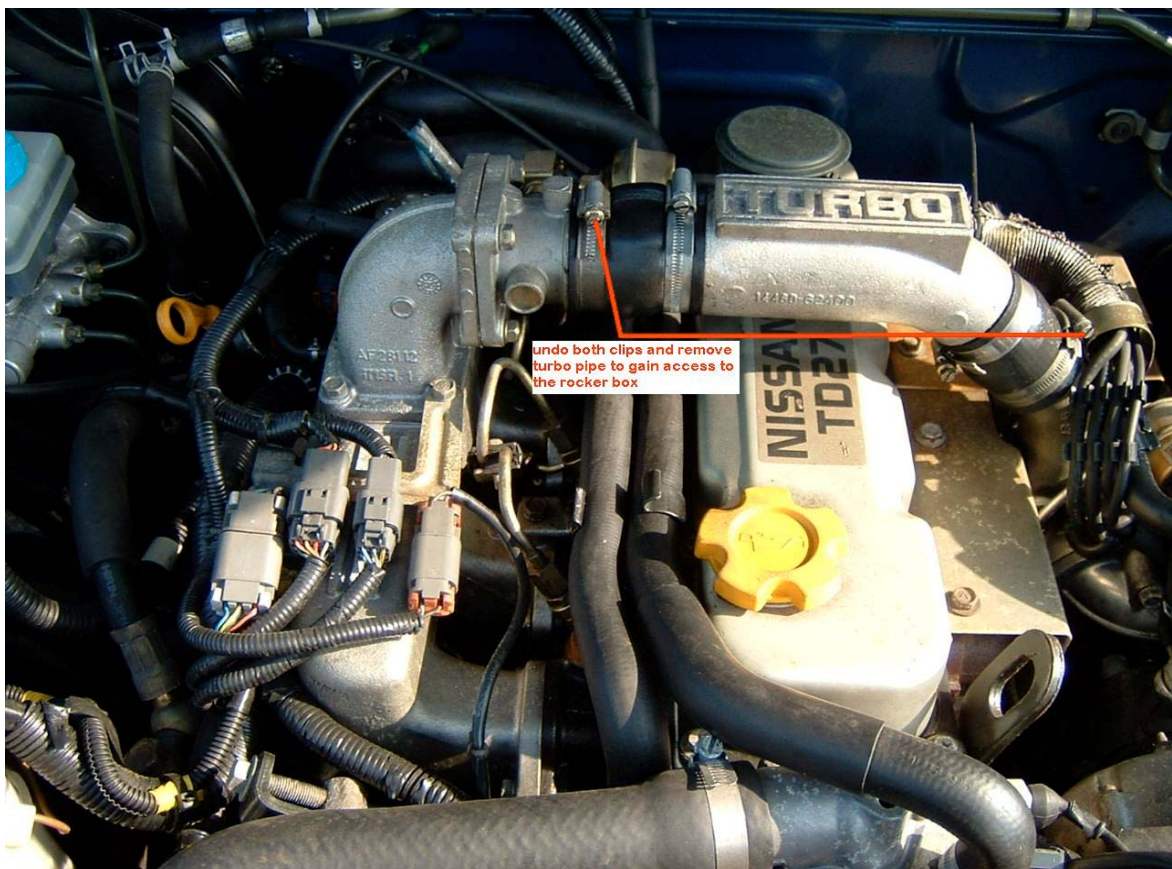
Start by removing the two jubilee clips at each end of the turbo air ducting pipe as shown.

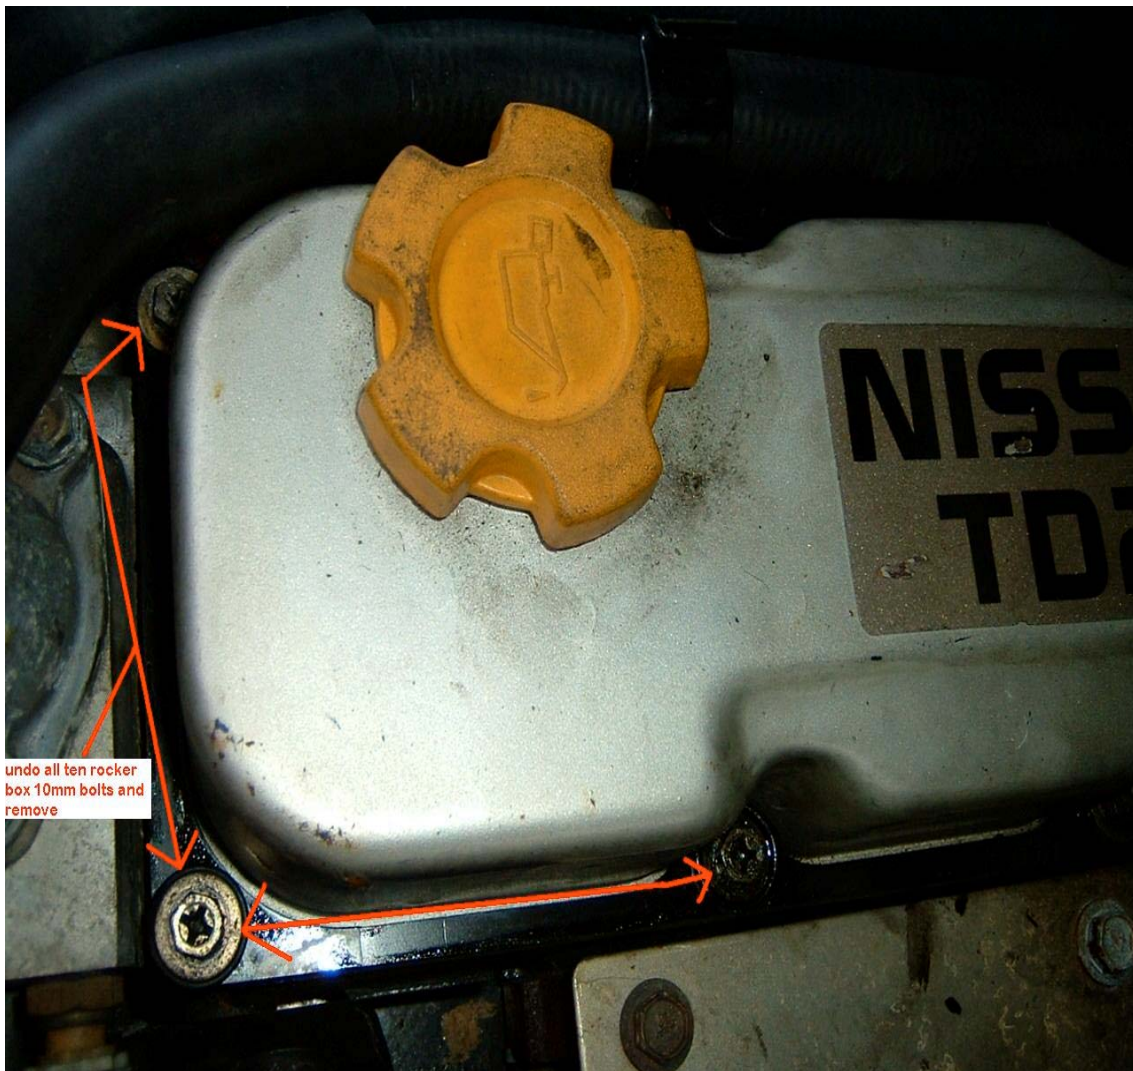
Next remove the ten bolts from the rocker box which are 10mm and remove the rocker box to reveal the rocker shaft and rocker arms.

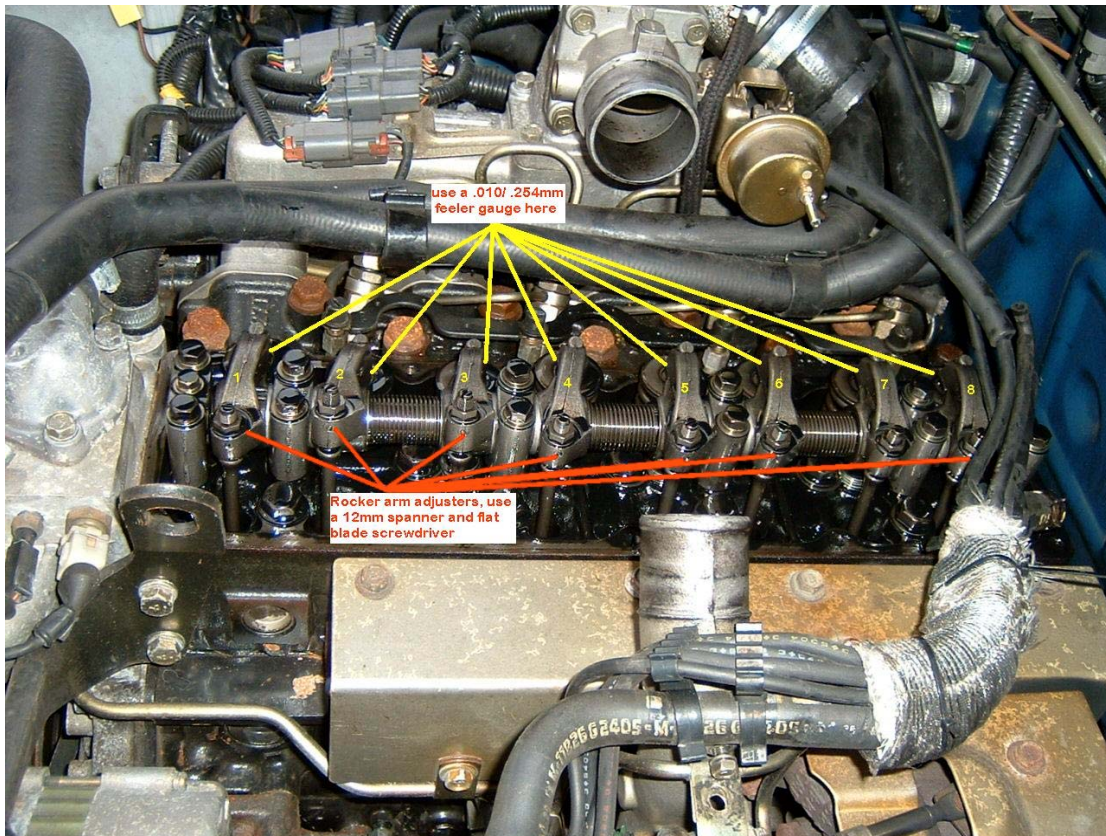
The main cause of top end engine rattle is when the rockers strike face naturally wears, and the gap between the rockers and valve stems widen, the procedure then is to adjust the gaps back to the manufactures specified gaps,

Next turn the engine clockwise using the 19mm top pulley nut until the number one piston (Radiator end of rocker shaft) is at top dead centre stroke, you will find rockers number 1,2,3 and 6 are able to move freely and can be adjusted to .010/ .254mm feeler gauge gap, if adjustment is needed, undo the 12mm rocker nut and turn the adjuster with a flat blade screwdriver until the gap is achieved, once all four rockers have been adjusted turn the engine again until piston number four is at top dead centre stroke and rockers 4,5,7 and 8 are free rocking, then check and adjust these as you did the other four with the same feeler gauge size, make sure all 12mm nuts on rockers are tight and re-check gaps before replacing rocker box and turbo air duct in reverse order.
