Workshop 44

Replacing universal joints on the rear prop shaft of a Nissan Terrano

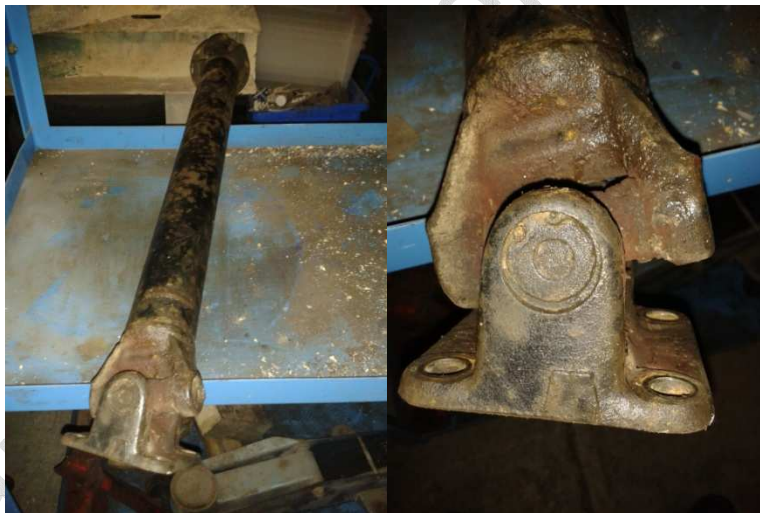
Here you can see the prop shaft having been removed and the circlips

Next the circlips are removed, they were very awkward and i actually bent a pair of circlip pliers trying to get the first one out, i found it easier to bash the end of the circlip and forcing it to close on itself and hold in all the crap and muck whilst i then prized it out.

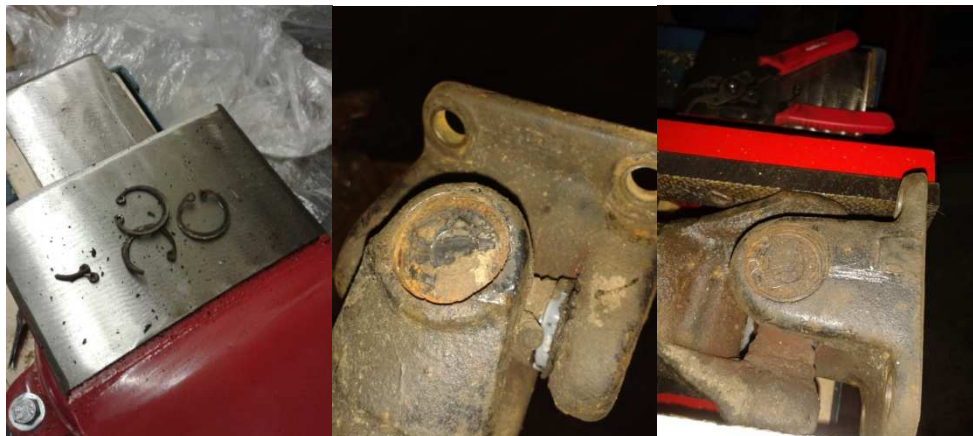
It is also important to remember to mark the saddle and shaft so that they go back where they came from as the shaft would have been balanced when originally built.

Next i got a socket small enough to push the universal joint out of its holder by pressing it in the vice, it takes a while and a lot of pressure but it suddenly popped.

Then i got another socket large enough to place over the other side so that the universal joint cup can be pressed almost all the way out, the last little bit is pulled out using a pair of grips.

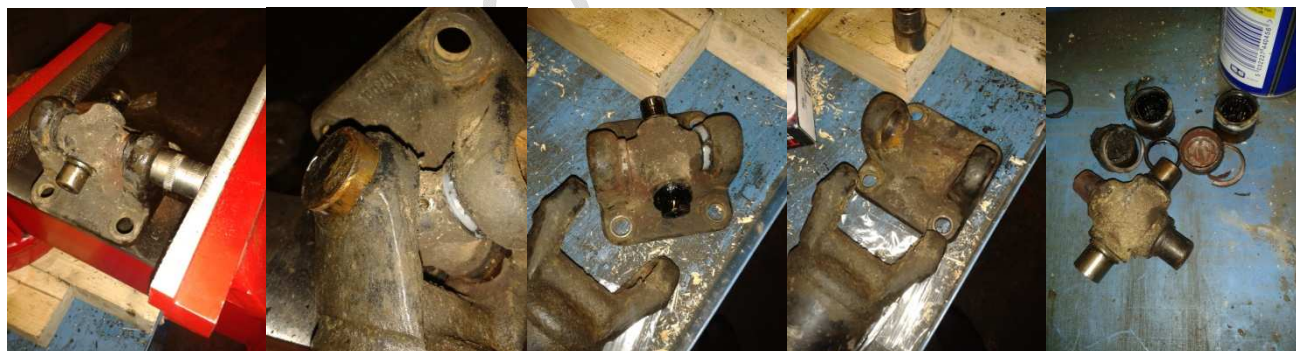
Time to clean all the surfaces up as well as the circlip rebate and a little bit of grease to help the cups slide back in.

Again it takes a bit of brute force but they do eventually pop into place, then to replace the circlips with new ones that came supplied with the kit and the grease nipple

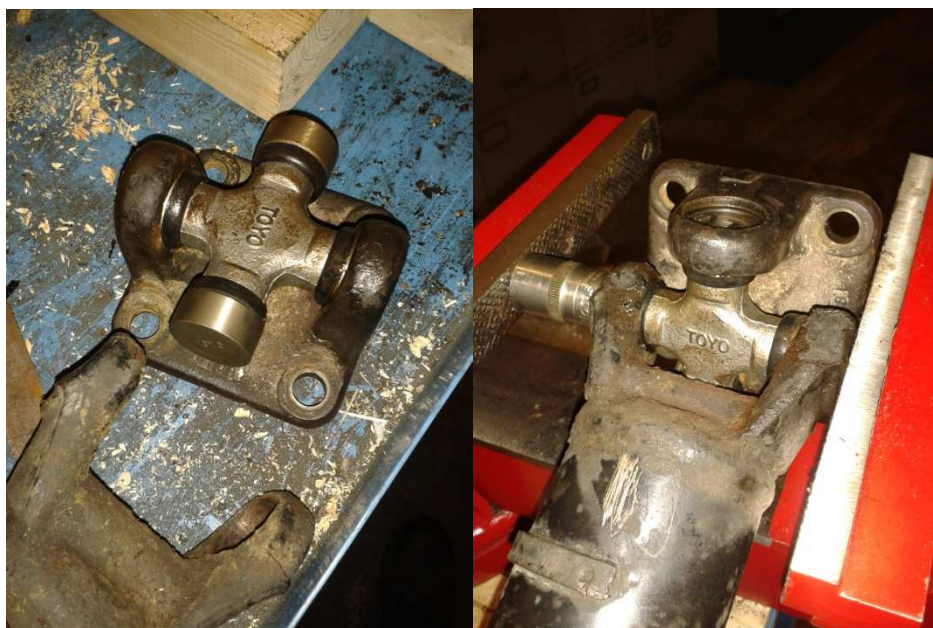
Fill with grease and same on the other end.

Once both ends are replaced simply slot the gearbox end of the shaft back in and secure the four nuts and bolts on the axle end.
