Workshop 12

+ Battery terminals connector problems

Terrano 2 1996 2.7Tdi SWB Extreme

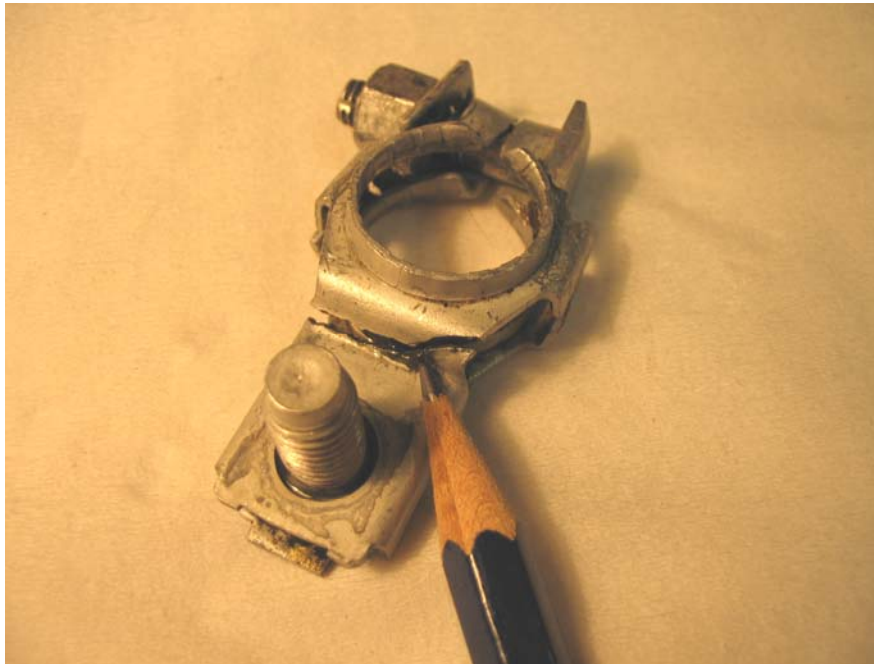
Picture No1

My T2 as a battery with round terminal posts, to allow the very thick starter wire to be bolted to the + battery terminal, a converter bracket (scrap junk) as been used (See Picture 1)

Due to the design of this piece of kit and the direction of the vibration of the engine it as cracked in such away as to remain connected but only with poor electrical contact.

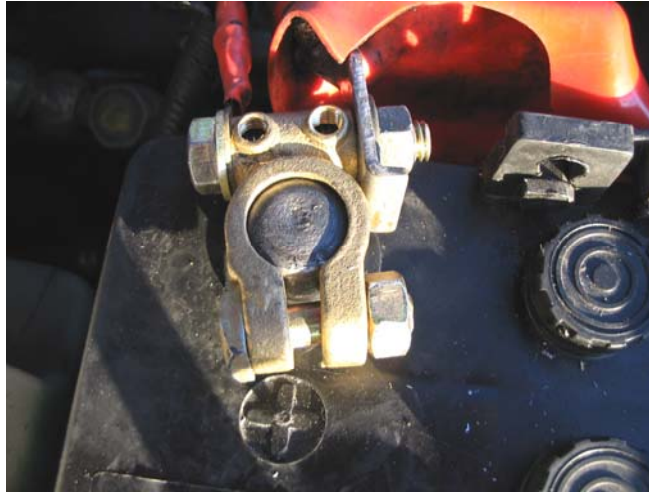
Picture No 2

Visiting my local motor factors, a standard battery positive post clamp and 8mm nut bolt & washers were purchased. (See Picture No2)

Assemble the post terminal 8mm nut and bolt as pictured above. taking care regarding the natural lie of the cable and vibration of the engine, also this connection will be required to pass 100's of amps on starting, therefore the mating surfaces need to be as large as possible, filing down the edges of the post clamp, that's the bit where the head of the bolt (that on the left in picture above) touches the clamp, and were the spade from the starter wire touches the clamp (that's on the right in picture above) to provide good mating surfaces is good engineering practice, what i believe to be the charging lead (much smaller in diameter is connected under the bolt head on the left in the above picture).

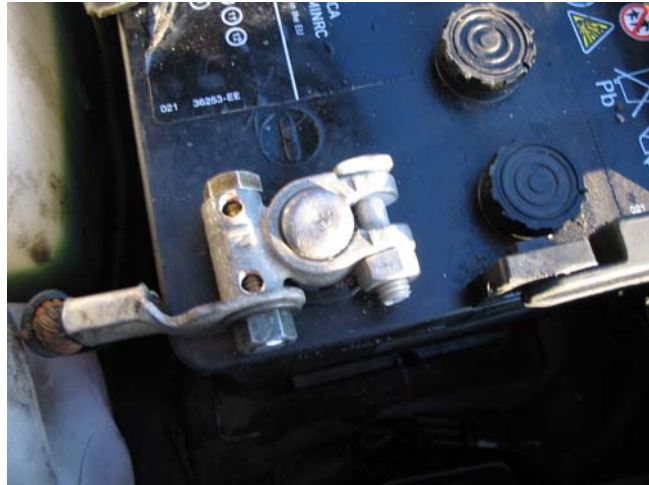
Picture No 3

I also changed the negative terminal (picture No3) just in case, though this does not suffer as much movement as the positive terminal.

Remember to unlock all the doors before disconnecting the battery and grease up the battery terminals afterwards to protect them from corrosion.
