Workshop 45

Replacing rear anti roll bar drop links on a 1998 Nissan Terrano.

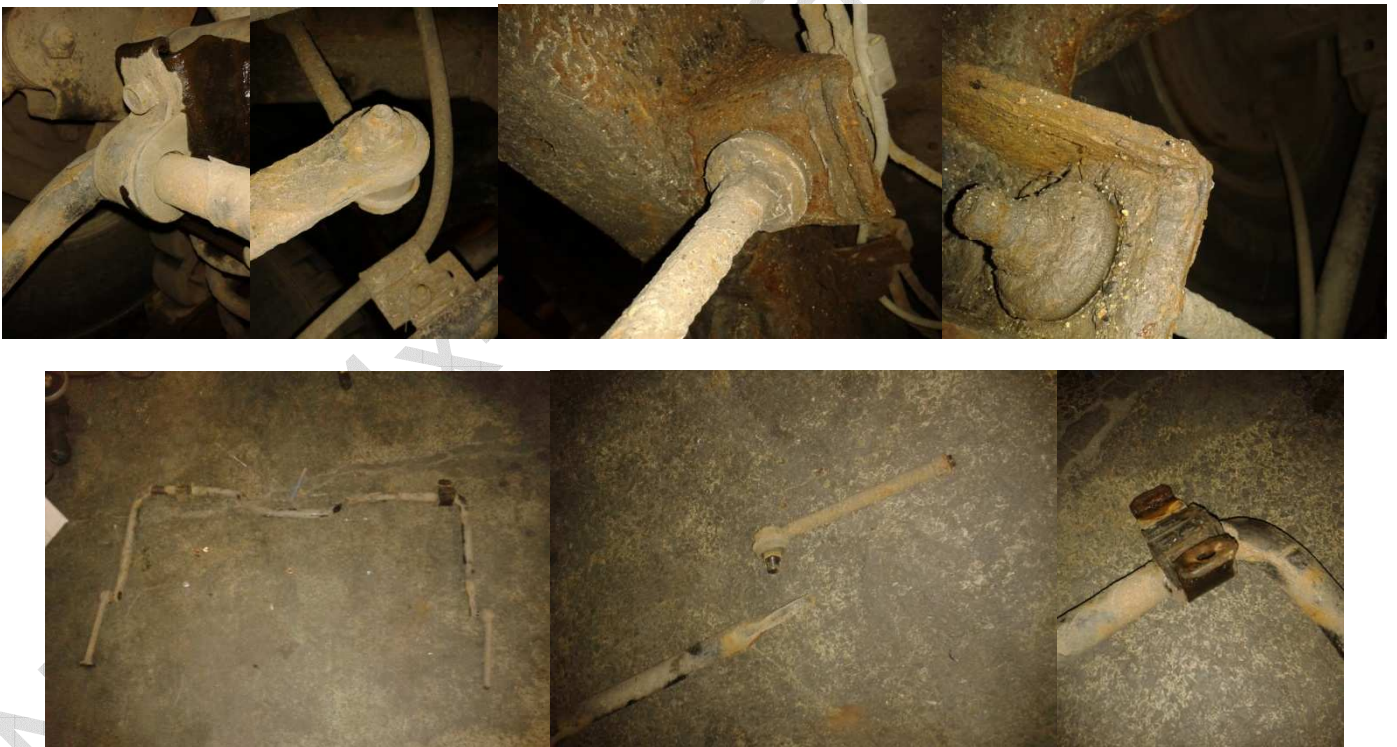
I started by jacking up the rear and sitting on axle stands to take the wheels off the ground and remove some pressure off the anti roll bar, next i sprayed a little WD40 on the threads where possible, the double centre mounts came undone with relative ease. Having looked at the nuts securing the drop links i decided as i was replacing with new to let Mr Grinder do his stuff and cut them off, i then dropped the roll bar on the floor and cut the ball joint end off too.

Now that the roll bar is removed and the drop links are also removed i can now replace with the new ones along with the poly bushes and refit back on the car.

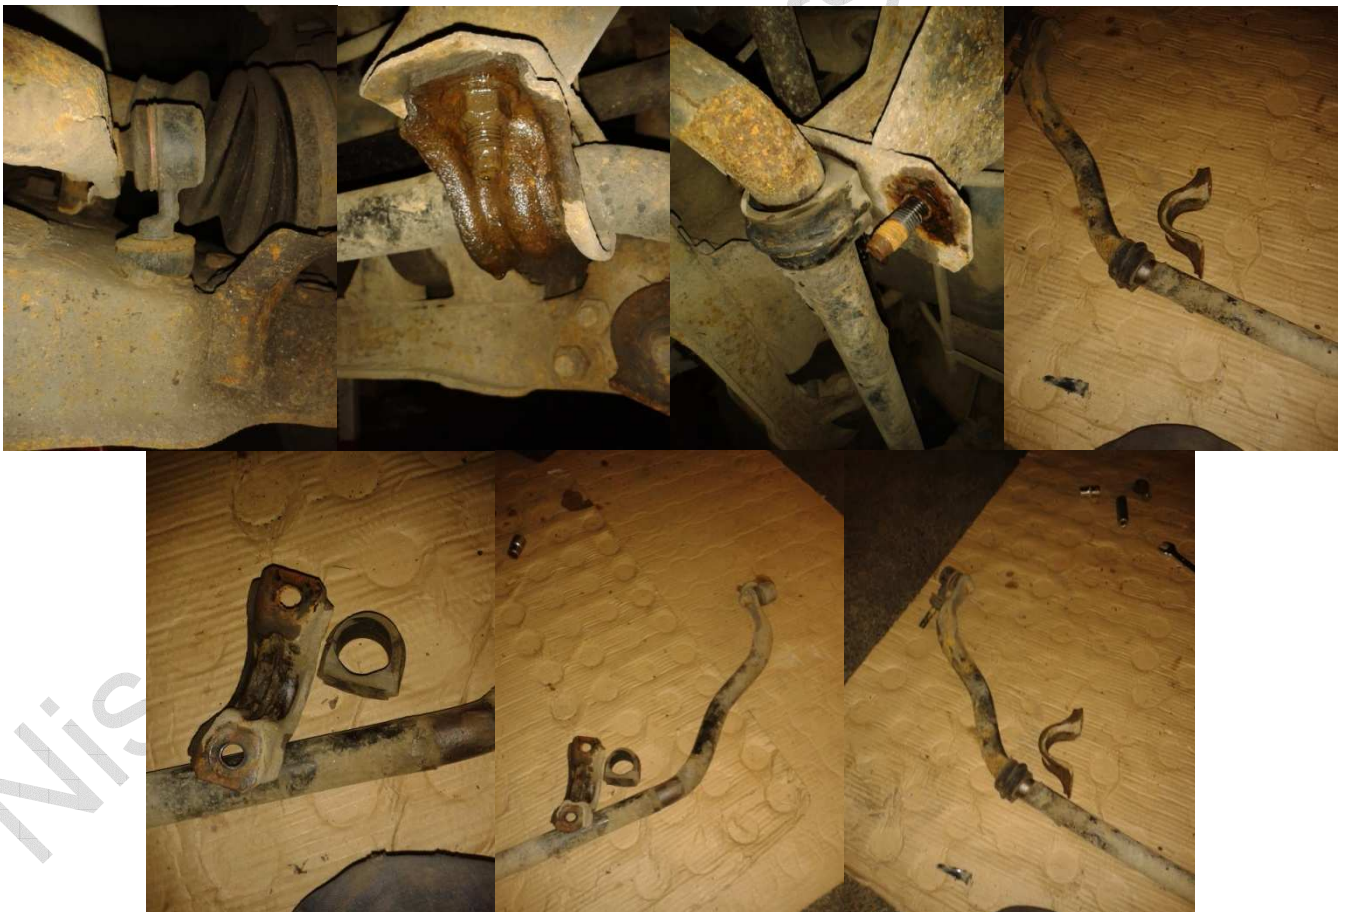
As you can see from the first picture the black rubbers have already begun to crack and perish.

The drop links were undone through the bottom suspension arm and then the double mounting in the centre were undone and the anti roll bar was dropped off

Now to refit the bushes were simply slipped onto the anti roll bar and it was then remounted, fixing the drop links in place and then mounting and securing the double centre mounts.

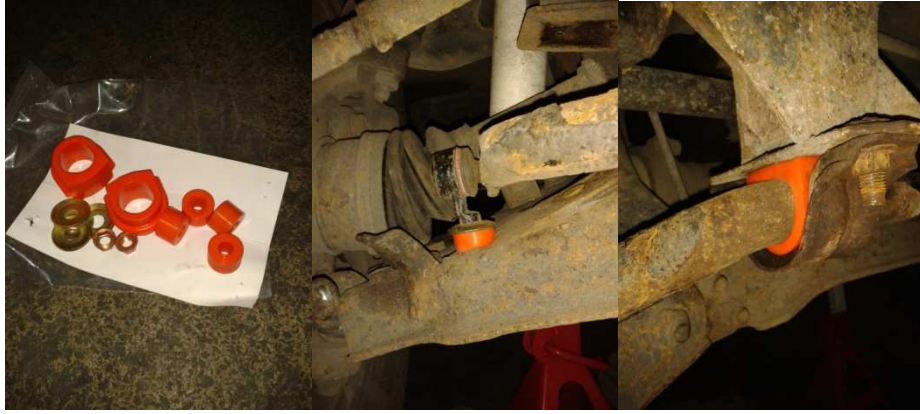
Job done, in total i would say it took approximately 2 hours to do both the front and rear and best of all they are a nice bright orange colour.
