Workshop 18

Cheap replacement for the heater speed control resistor TerranoII – Maverick - Mistral

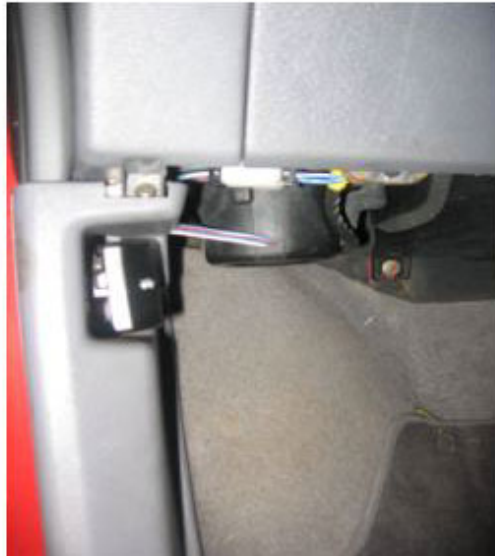
1

This is a fix for those of us, and there are many, whose heater blower will only work on the maximum setting of number 4. Firstly, locate your heater blower, I have a '96 Terrano 2.7TD SE Touring + Aircon and the blower is located in a corner of the front passenger footwell behind the glove box and just above the bonnet release, as in picture 1:-

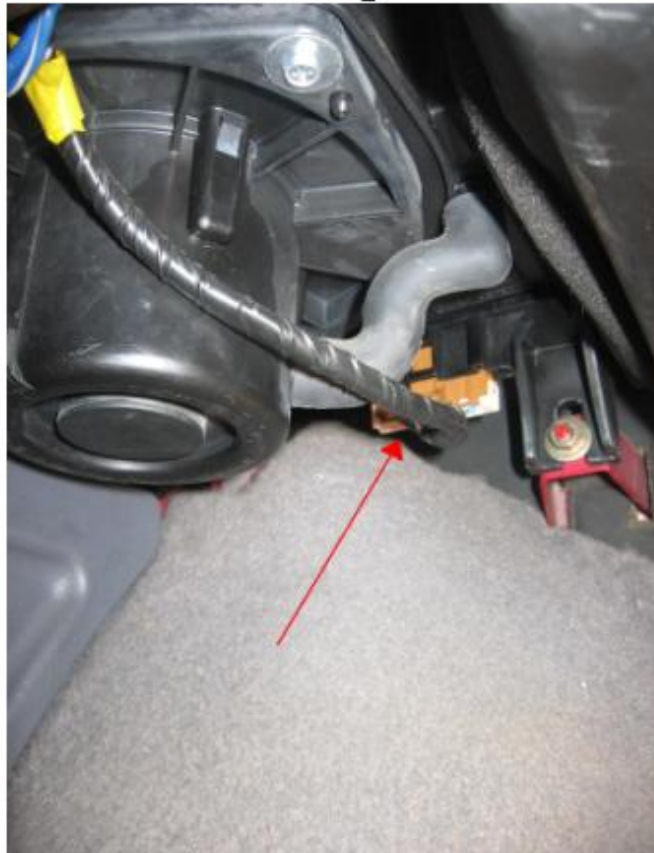
2

The part you need to replace is located almost up against the bulkhead and is secured by two screws, if you are a bit of a contortionist you should be able to get at them without removing anything else, eg. glove box. see picture 2:-

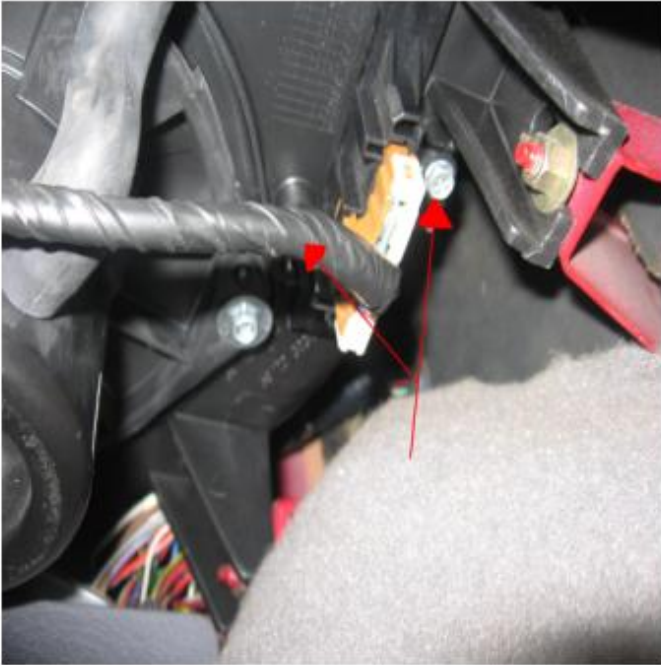
3

Undo the two screws and withdraw the resistor downwards, then remove the plug connector by squeezing the top of the brown retaining clip, you have now removed the defective heater blower resistor. See pic 3& 4:-

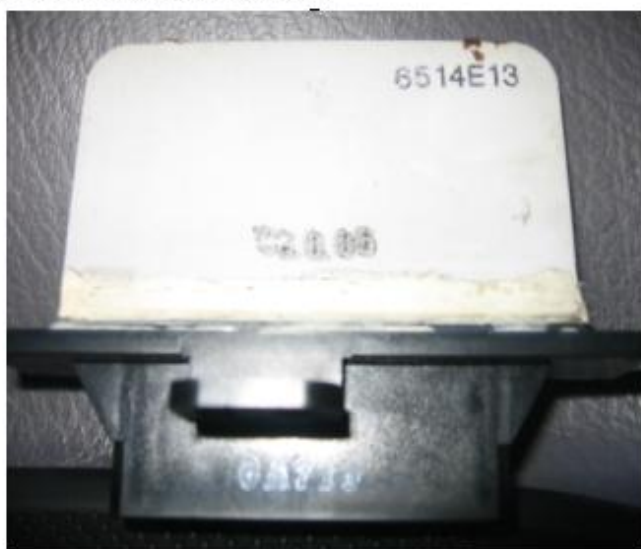
All you need to do now is connect the replacement part to the plug, insert into the blower, do up the two screws (short screwdriver required), and enjoy the fact that you no longer have to have a shouted conversation with your passengers whilst driving your pride and joy! A new replacement part can be had for about £40, or you can do what I did and visit your local scrapyards where I got a replacement part from a "V" reg Nissan Almera for the princely sum of £2.50, although this has a different part No. from the original Terrano resistor that I removed, although if you choose this course of action, I accept no responsibility if all goes wrong, so please check if this is the correct part for you, etc etc etc. For different part numbers see picture 5, the defective part I removed, and picture 6, the part from the Almera :-
