# Workshop 37

Auto free wheel hub strip, clean and re grease  
Maverick 1997 2.7 TDI

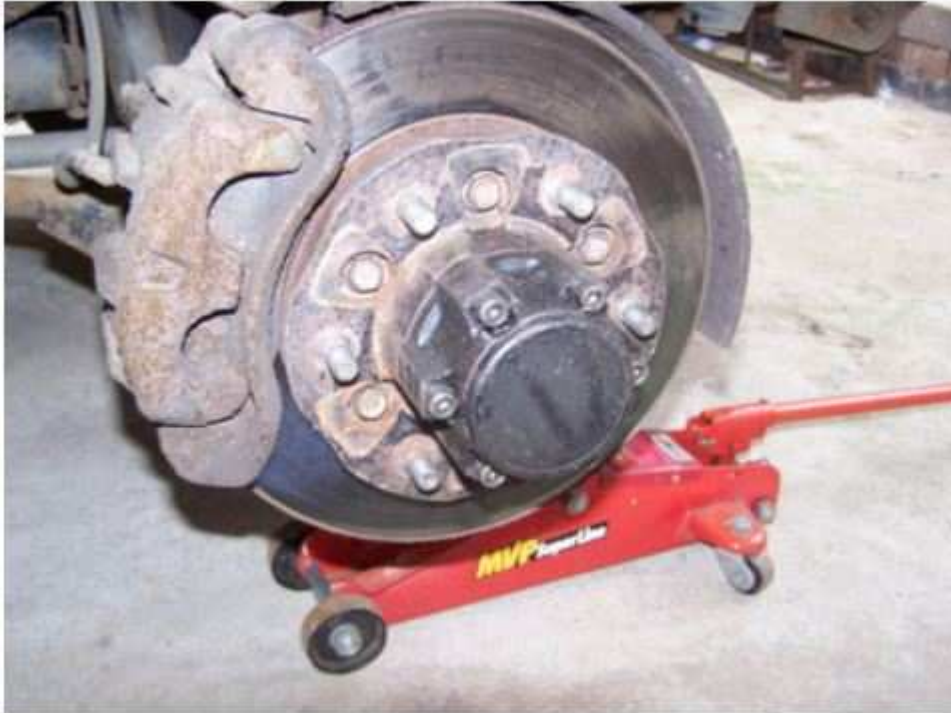
First remove the wheel, exposing the hub. the hub will need the 6 alen key bolts removing, they should not be too tight.

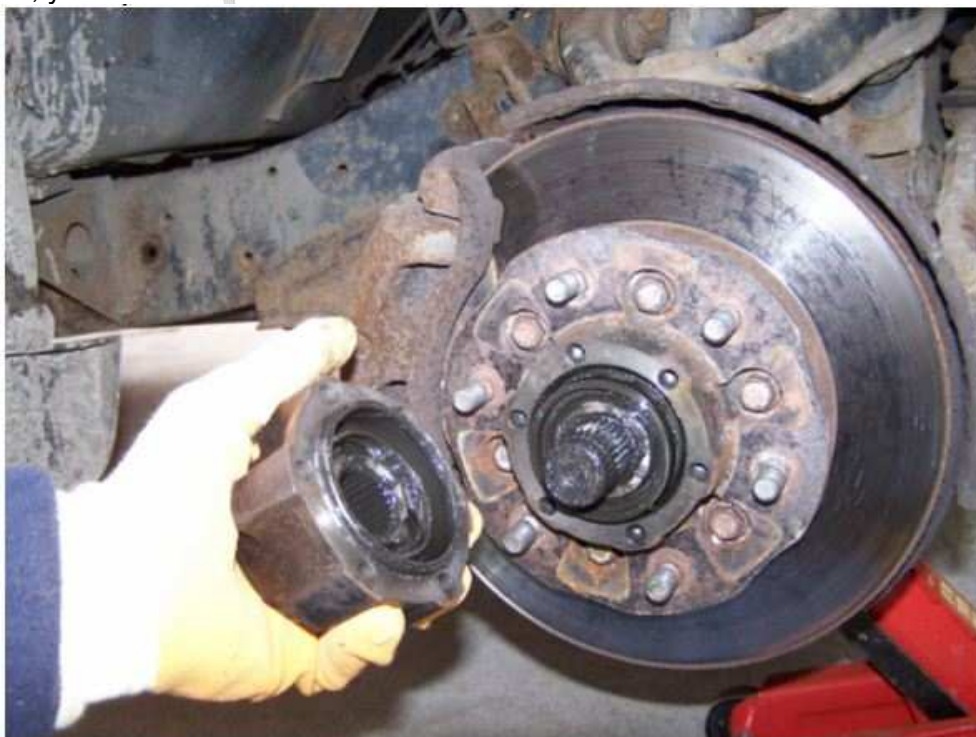
Once removed you will be able to prise the hub away from the wheel disk, I used a rubber mallet to break the seal, but don't hit it too hard, you don't need too.

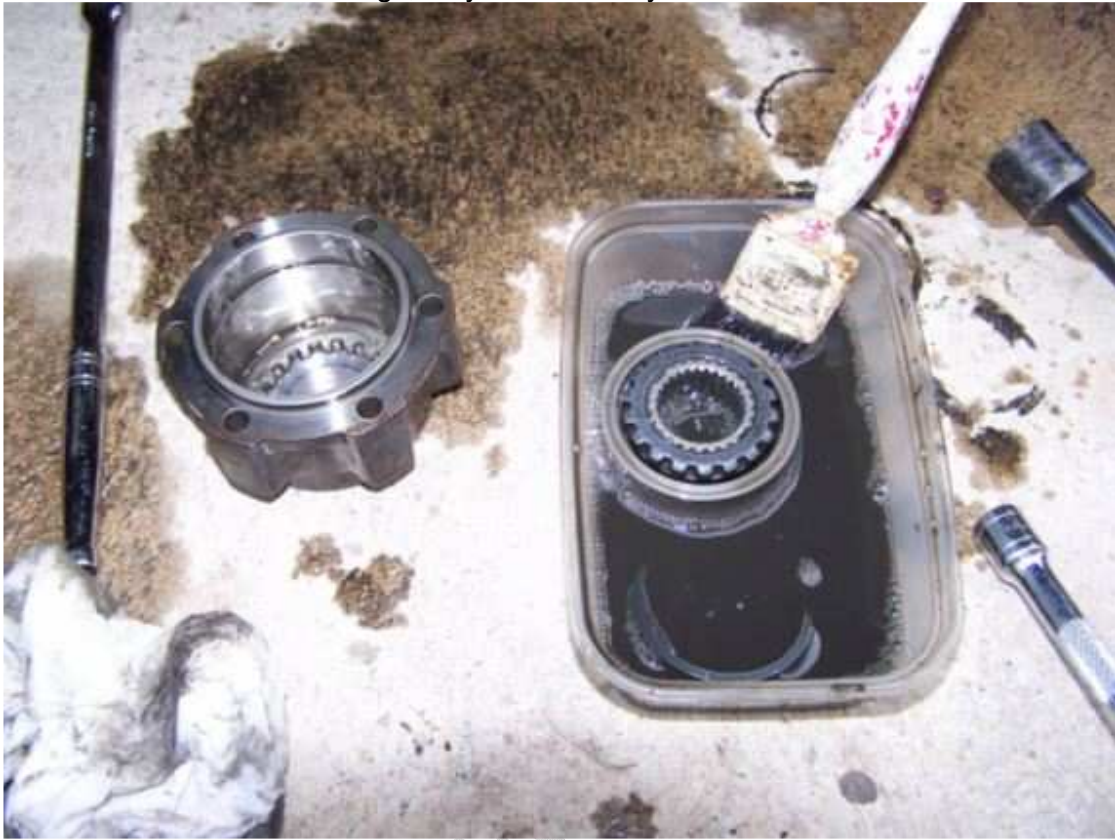
The locking ring the holds in the slinky spring is the first part to remove, it just turns 1/4 turn and pops off, then remove Mr Slinky. the rest is as described in the download section. Take it all to bits and clean. Watch out for the last part that comes out, its full of ball bearings, they do fall out if your not careful.

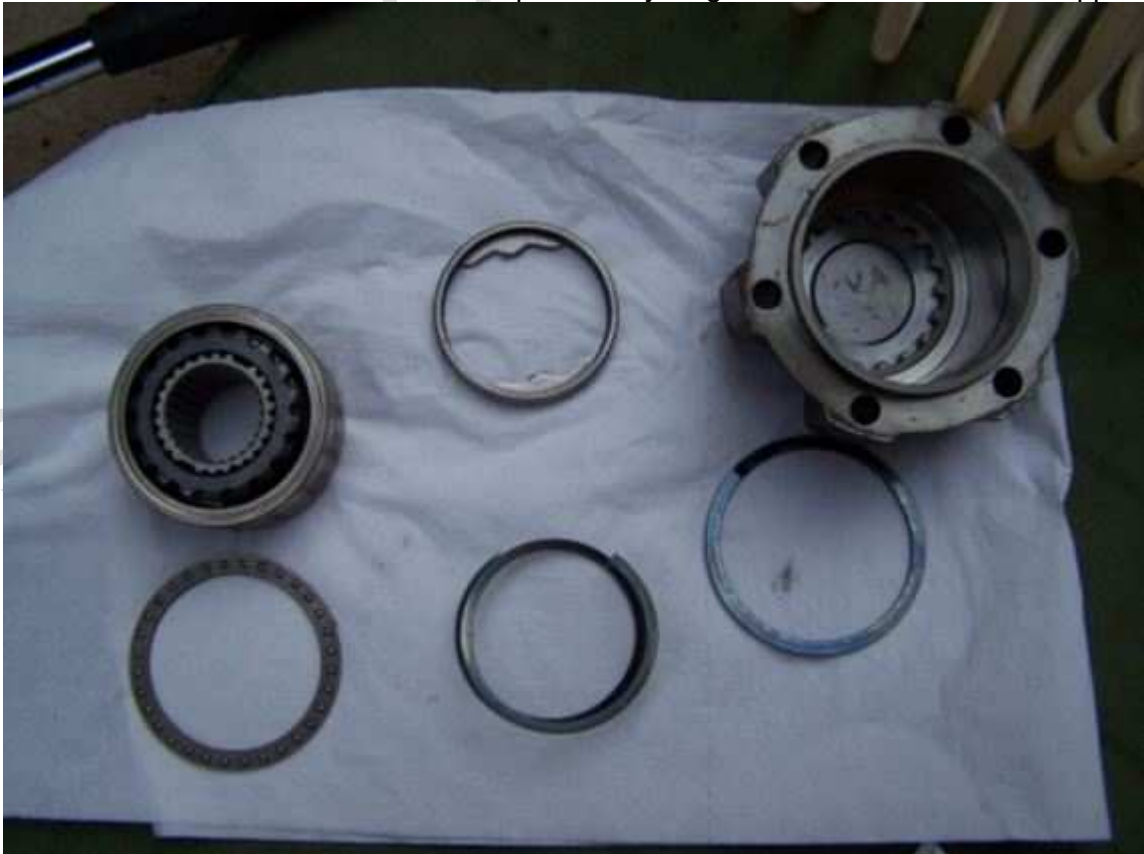
Once clean, "DRY EVERYTHING" don't leave white spirit on anything or it will break down the copper grease.

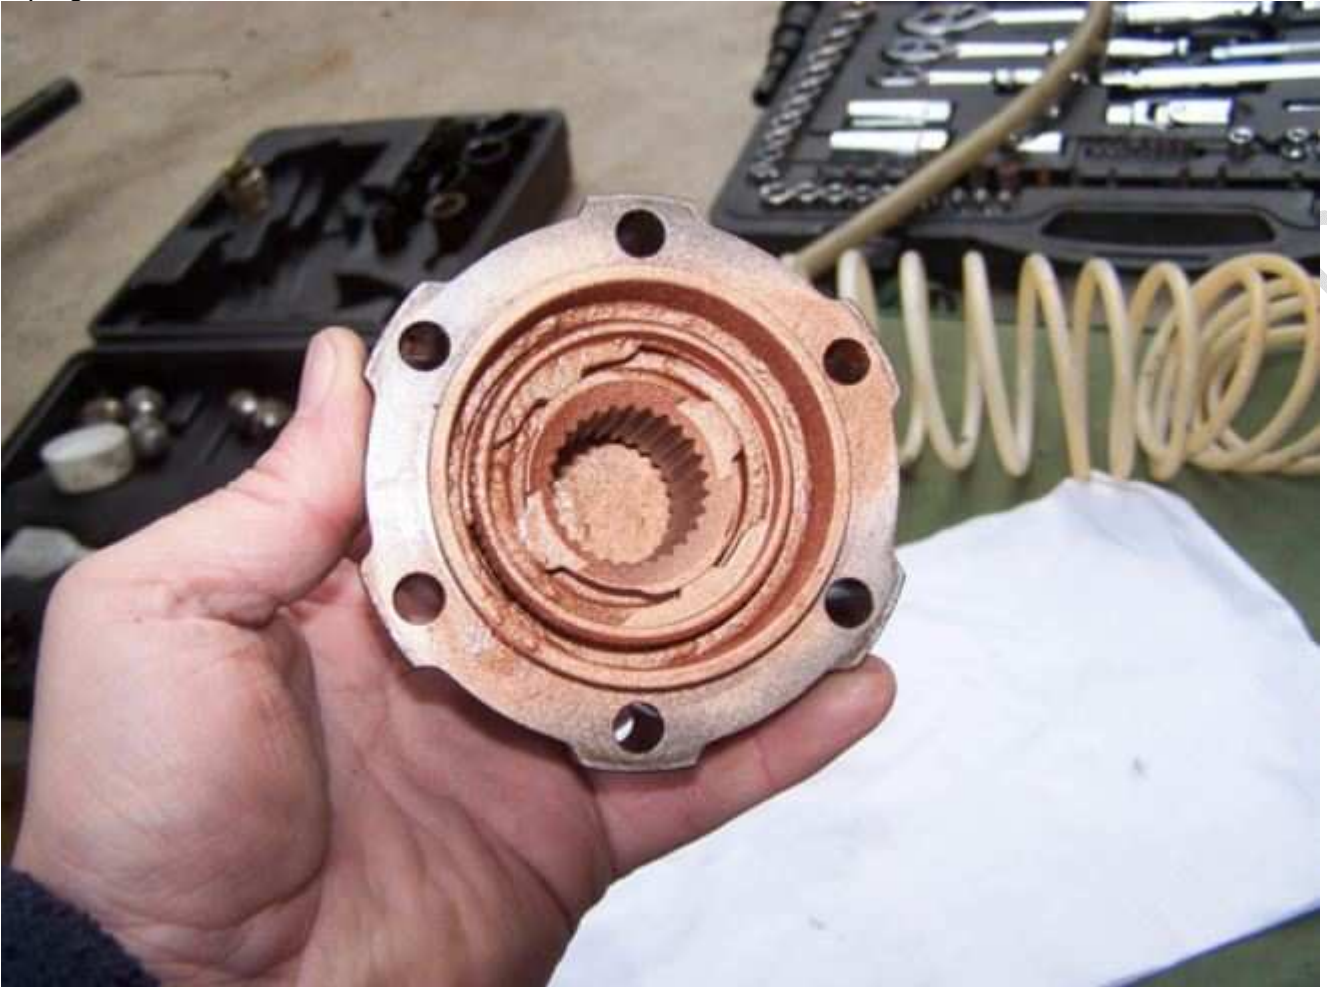
Make sure its CLEAN, then start coating with cooper coat as you rebuild it, but not too much, you don't want it to get gobbled up again.
