Workshop 4

Replacing Cabin Filter

Terrano II 2.7tdi SE+ Year 2000

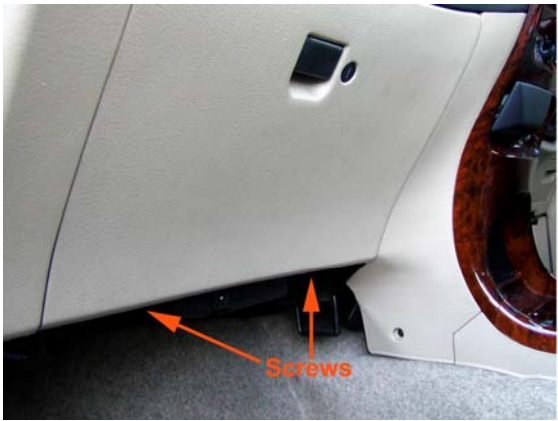
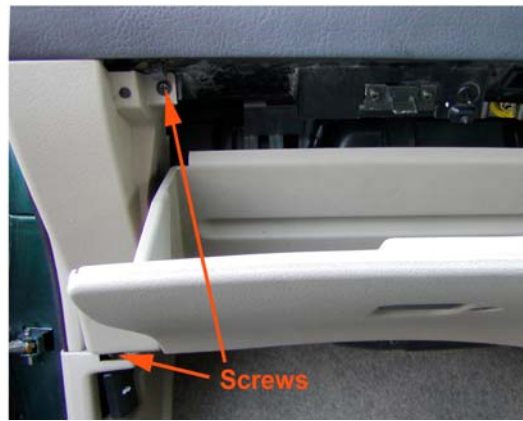
- Remove the two screws from the hinges on the lower edge of the glove box.
- Remove the two screws on the left-hand panel, there are actually three but you cannot get to the third one yet.
- Pull off a small amount of the rubber door strip next to this panel.

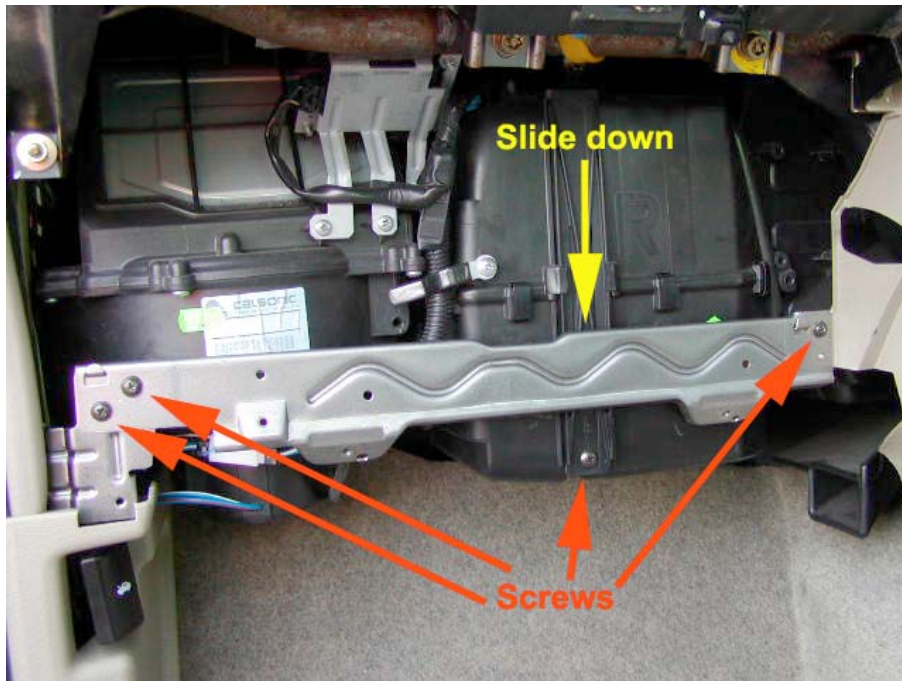
- Now gently ease the left-hand panel towards the door....there is still one screw still holding it so don't over do it.
 - Tilt the glove box door up at one end , this will allow you to remove the door with a bit of jiggling of the left hand panel.
 - With the glove box door now removed the third screw in the left-hand panel is now accessible and should now be removed.
-
- Remove the three screws from the steel cross bar.
 - Lift the cross bar from the lower edge up towards yourself and unhook from the two hangers.
 - Remove the single screw from the filter cover and the slide the small panel downwards to reveal the filter.
 - Now pull the filter out of its housing.

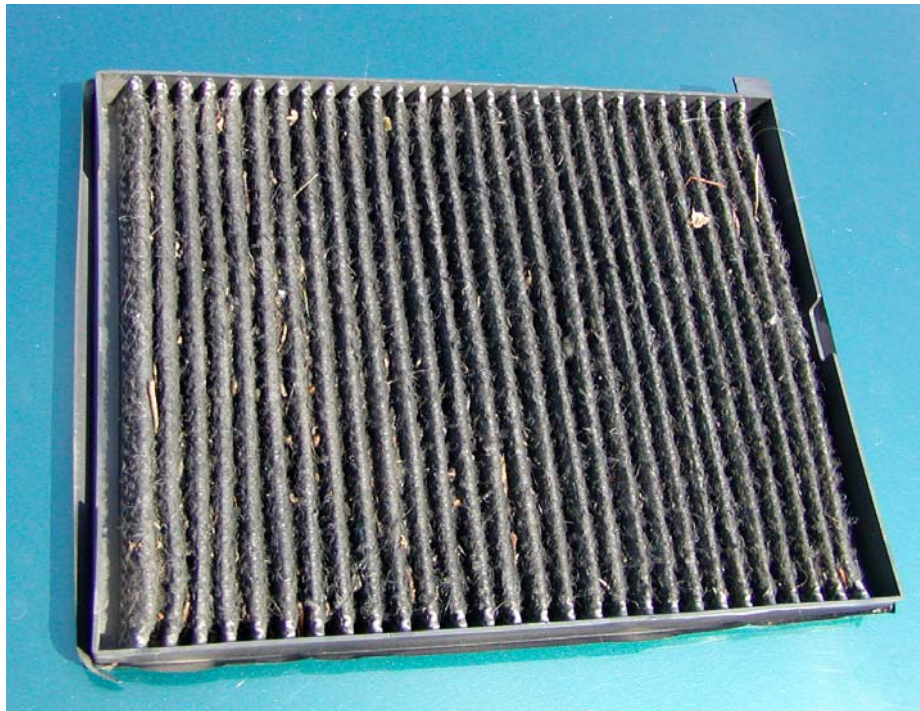
One blocked Filter

- Fit a new filter and reassemble by reversing the above sequence.
